**ALABAMA HAZARDOUS WASTES MANAGEMENT AND MINIMIZATION ACT
(AHWMMA)**

Compliance Evaluation Inspection (CEI) Report

Rehau Auto LLC & Rehau Construction LLC (Rehau)
2424 Industrial Drive SW
Cullman, AL 35055
EPA ID Number: ALR000000612
NAICS Code: 326199
Website: www.Rehau.com

12/2/2019

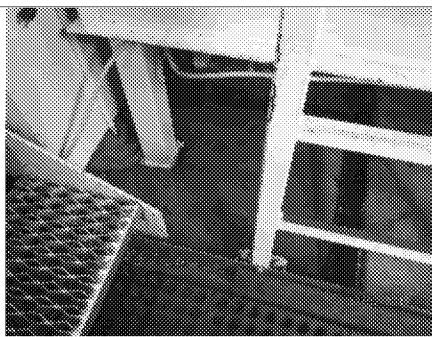
There were three mop buckets on the floor with oily water in them. The contents of the buckets will be poured into the oil/water separator, according to Mr. Mullaney. One 300 gallon tote of used hydraulic fluid was observed on a transfer platform. This platform also served as the secondary containment a secondary-containment for the tote and it was completely filled with used oil. One 55-gallon drum for used oil was observed open and not labeled with the words "Used Oil". No other concerns were noted in this area.

Used Oil in Secondary Containment

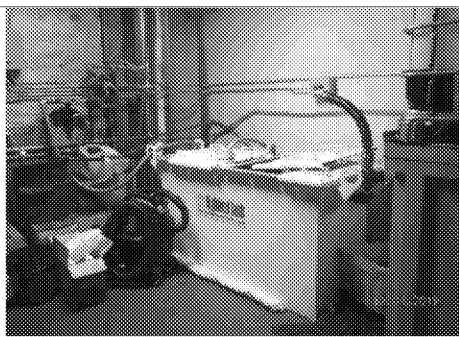
Oil/Water Separator and one mop bucket
containing oily water

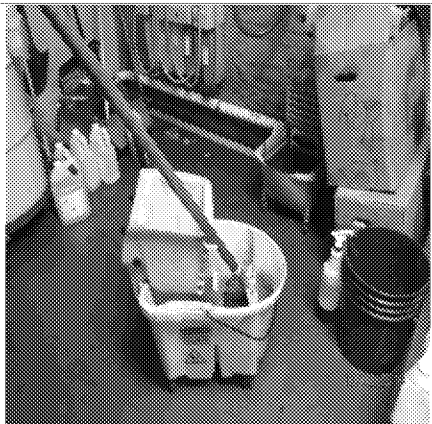
mop bucket containing oily water

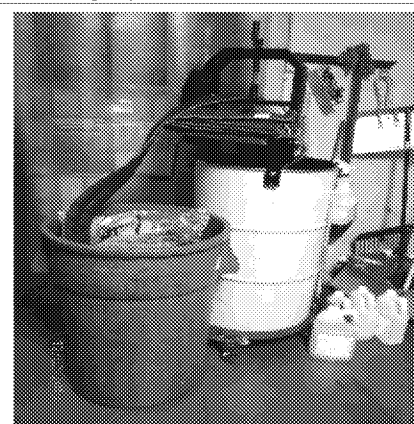
Absorbent pads satellite accumulation

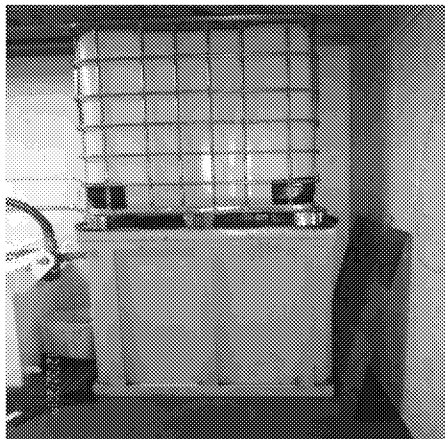
300 gallon Tote Platform

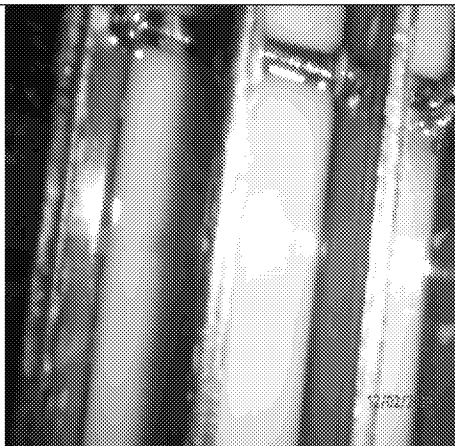
Secondary Containment; Tote Platform

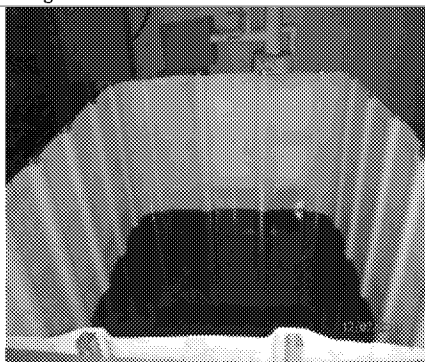
Commented [WP2]: What about outside the Oil water separator room? The totes and drums of oily water, the gailords of oily debris the open tote split in half with used oil inside, the oily stains on the ground, etc.?

Used oil in a tote that was cut in half

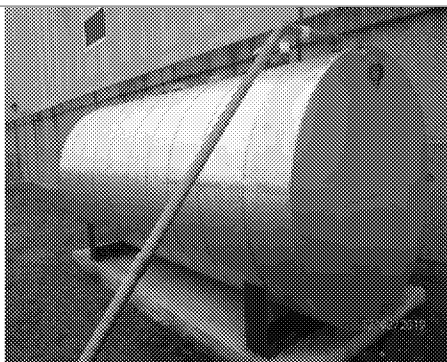
The used oil storage tank is adjacent to the oil/water separator room on a concrete pad on the outside of the building. The tank is approximately 10,000 gallons. The tank was not labeled with the words "Used Oil", but was in good condition. No other concerns were noted in this area.

Used oil storage tank

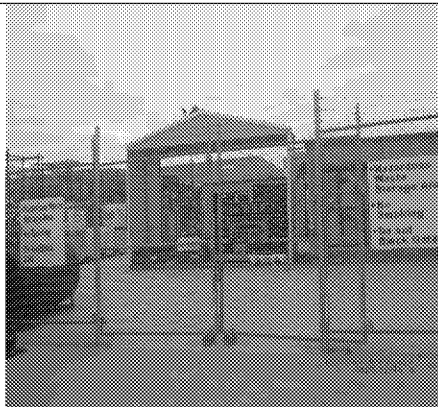
Hazardous Waste Storage Area

The hazardous waste storage area is also located on the south side of the facility in a fenced area outside. The area has the appropriate signage at every approach and has a means to control access to the area. There were fifty-five 55-gallon drums, one 300-gallon tote, and four 3-gallon buckets of hazardous waste in the area. All of the containers were closed, labeled, dated, and in good condition. The oldest container was dated 9/14/19. The secondary containment appeared to be in good condition and was free of any cracks or gaps. No areas of concern were noted in this area.

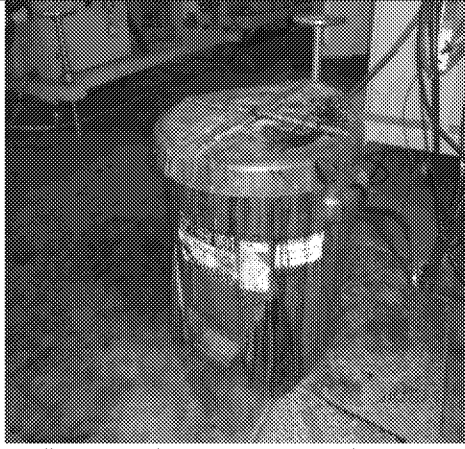
In this area, plastic pellets are extruded into hollow tubing of varying diameters for various application. There was one 55-gallon drum designated for hazardous waste at the beginning of the line. The drum was labeled, but not closed. This area has approximately twelve production lines with a 5-gallon satellite accumulation container at the end of each line. All of these containers were missing the words "Hazardous Waste". No other areas of concern were noted in this area.

Satellite Accumulation Container; PEX line
